# Farmar 54 Battery

Latitude 31.242700, Longitude -100.970433  
Irion County, Texas

January 31, 2022

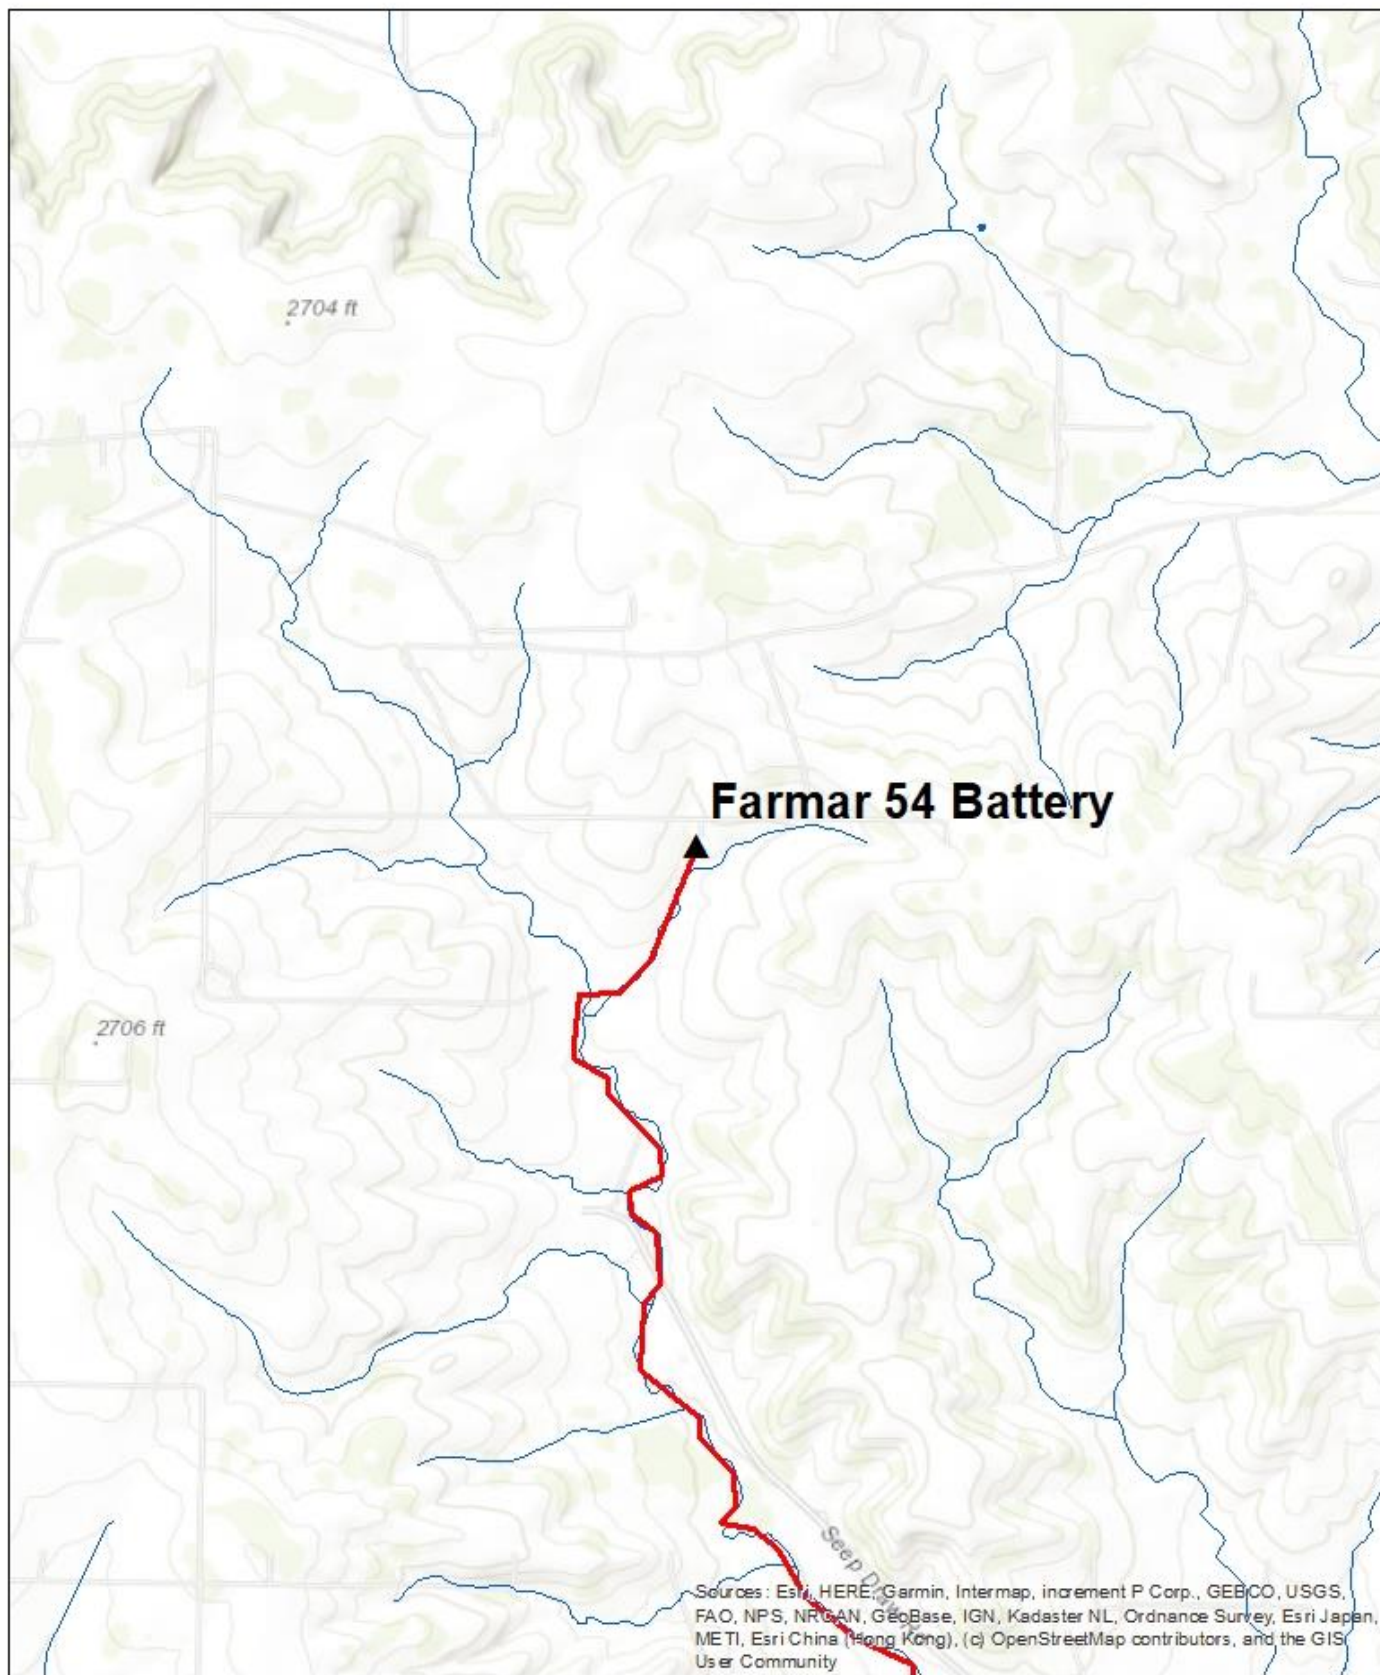
Discharged Topographic Map  
Triple Crown Resources  
Farmar 54 Battery  
31.242700, -100.970433  
Irion County, Texas
